Placer-Sierra Railroad Heritage Society

1912 WRECK OF SP 4208 PASSENGER CAB-FORWARD

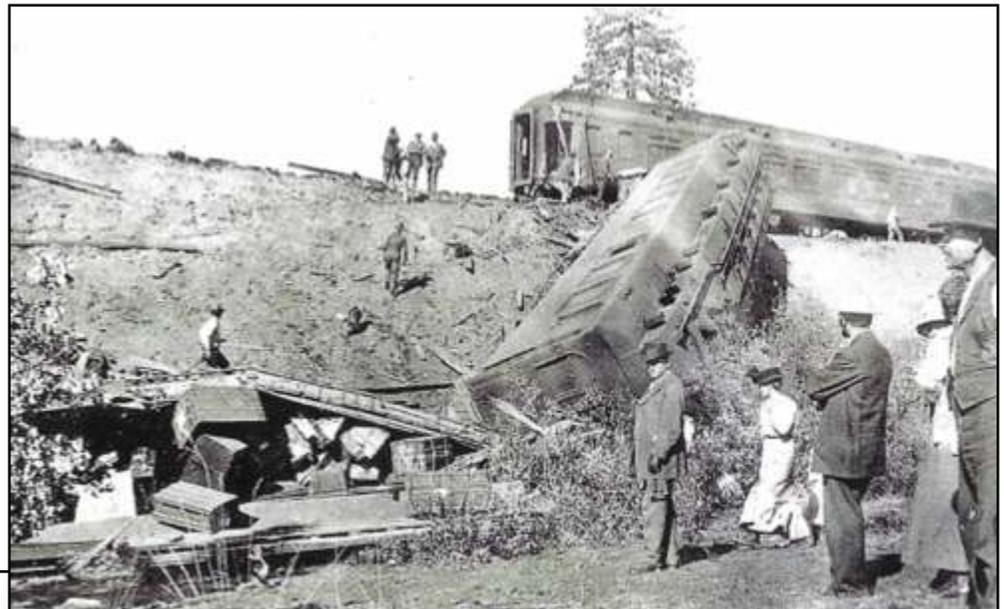
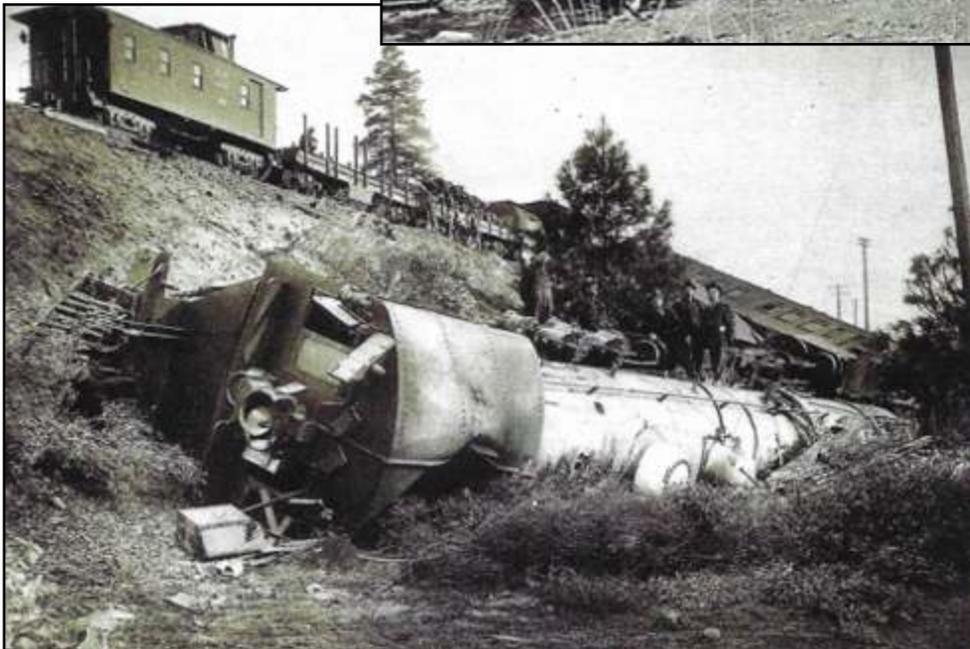
The Mallet engine, dynamo and baggage car and diner turned completely over after reaching the bottom of the embankment. The two sleeping cars were derailed but did not upset.

Engineer Brown died Wednesday evening. The board of inquiry laid the accident to spreading of rails."

Photos of Wreck of SP 4208 taken by a passenger - *S-P Trainline Winter 2025*

A second Board of Inquiry was formed and their reported cause was the rail turning over. They also mentioned that the locomotive design may have contributed, since it was really a locomotive operating backwards with the trailing wheels now leading, and perhaps they were not properly designed for that role.

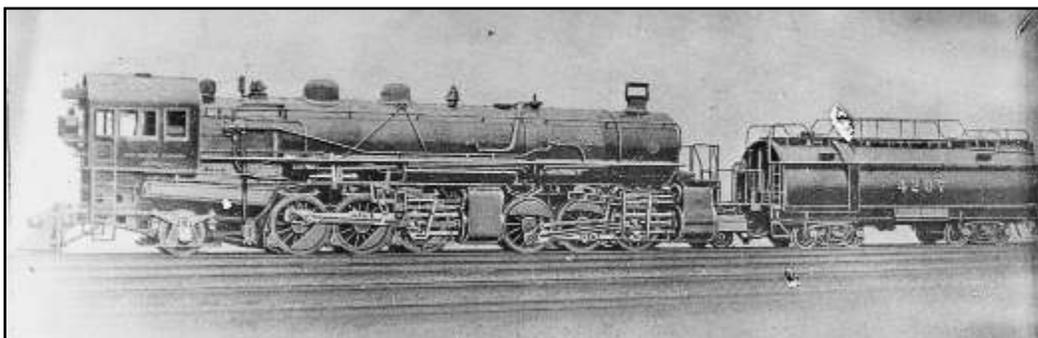
New SP President William Sproule was increasingly unhappy with each succeeding Board of Inquiry failing to find a direct cause of the derailment. He called for a third Board of Inquiry that included a series of instrumented test runs of a sister locomotive, SP 4207 that showed slight instability on curves when approaching 30 mph, while causing the driver wheels to bang against the inside of the rail at speeds above 34. The suspected cause was the large overhang of the firebox on this locomotive type, with the design of the lead wheels again being questioned. Despite these results the third Board concluded that the likely cause was excessive speed. The instability appeared to happen only above 30 mph. Since the posted speed limit was 25, the engineer must have been exceeding the speed limit. Sproule felt that the third Board of Inquiry gathered some important new information but their conclusions were not consistent with their findings.

SP 4207, a 2-6-6-2 cab-forward built for passenger service, was a sister to the engine that derailed in 1912 near Applegate. *Ken Yeo collection*

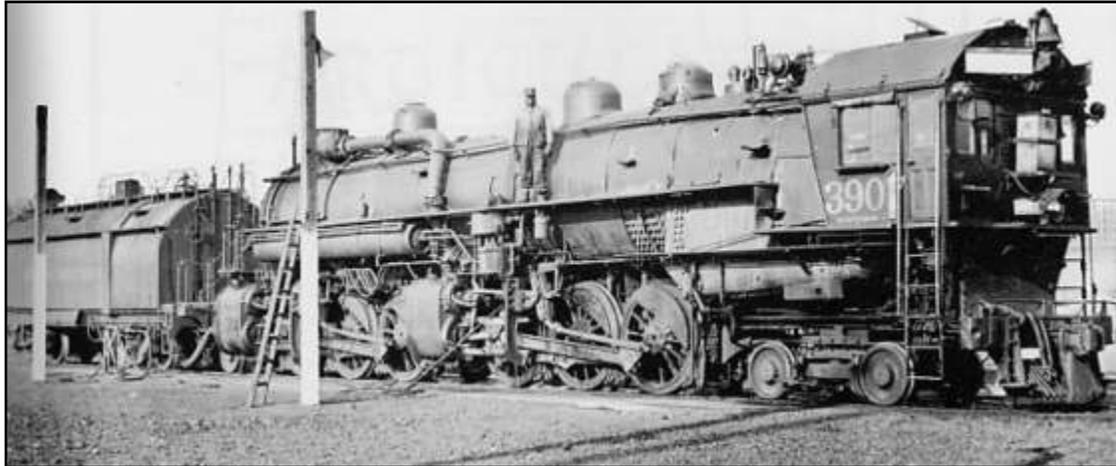
Resulting Modification from 2-6-6-2 to 4-6-6-2

SP 3907 in 4-6-6-2 configuration. In the 1930s SP renumbered the 4200 series passenger engines to the 3900 series. SP 3907 is the renumbered SP 4207 with the modified 4-wheel lead truck. *Ken Yeo collection*

This led SP and Baldwin to determine who had ordered the design change to put the cab ahead. Records showed that all that was ordered was to turn the engines around and modify the cab and other fittings as needed, with no mention of the design of the now leading wheels. SP agreed to purchase from Baldwin new four-wheel lead sets designed to steer the engine around curves. All remaining 2-6-6-2 cab-forwards became 4-6-6-2 and the derail problem was solved. However, the SP 4-6-6-2 cab-forwards were soon replaced by other locomotives for Donner passenger service, and the SP cab-forward 4-6-6-2 passenger locomotives were reassigned to other operational service.
